Building Exterior Visual Assessment (BEVA)

May 29, 2020

Executive Summary

In May 2020, Valiant Solutions performed a Building Exterior Visual Assessment (BEVA) at The Burj Khalifa.

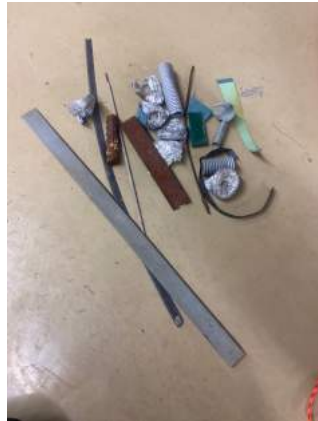
15 (loose debris)

Some loose debris was observed (and removed for safety) from the roof, including mastic tubes from roofing work. Recommend reminding roofer to clear all garbage from work area after service is performed.

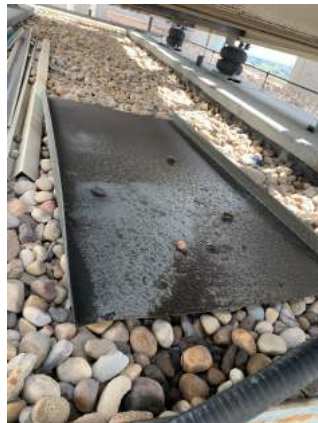
15 (loose debris)

There were a number of large steel flashings observed on the upper roof. These can be extremely dangerous if blown off the roof. We relocated them into the elevator room for safety.

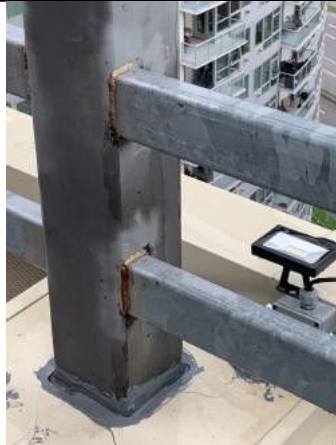
1

Observed rusting weld on steel work. Recommend sanding and sealing.

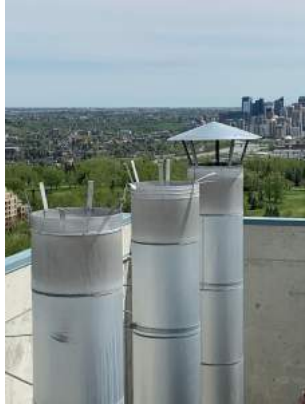
13

All rain caps appear to have rusting fasteners. Two of three have already been apparently torn off from wind. Recommend securing the remaining cap and replacing missing caps. These pose a severe threat to humans and property if not secured.

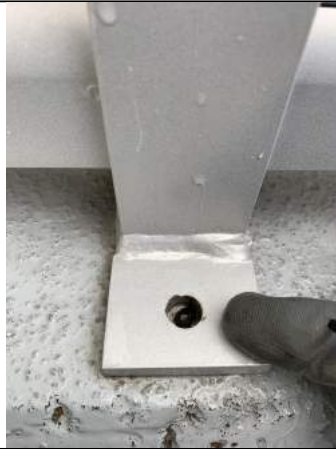
21

A significant number of balconies are missing the bolts that secure the railing to the concrete. This will lessen the amount of force that the railing is capable of sustaining.

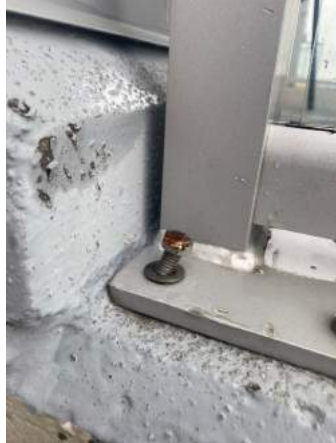
21

A significant number of balconies also have hardware that is deficient or installed improperly.

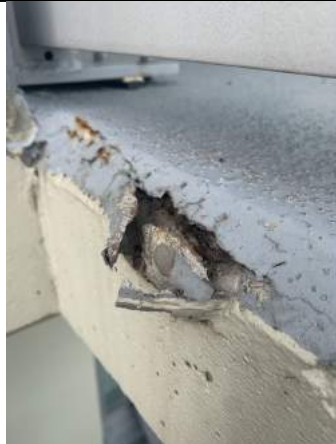
20

On many places accross the entire building, concrete edges on balconies are starting to fall apart. In many instances, pieces of concrete are already loose or have shed pieces.

1. The Concrete balcony slabs are in rough shape. Most balconies have at least some loose pieces of concrete, some have larger pieces ready to fall from the building.

Recommendation: Remove all loose pieces of concrete from the balconies to eliminate the immediate hazard to the public. Estimate for Valiant to complete this work is below.

This concrete needs to be assessed and resealed to prevent further deterioration. Valiant would be happy to help in the remediation process.

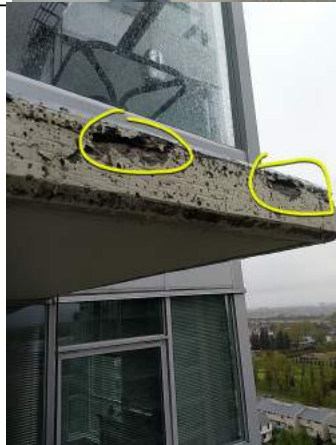
20

Immediate action needed. This is typical of many balcony slabs. Loose concrete posses a serious hazard to those below.

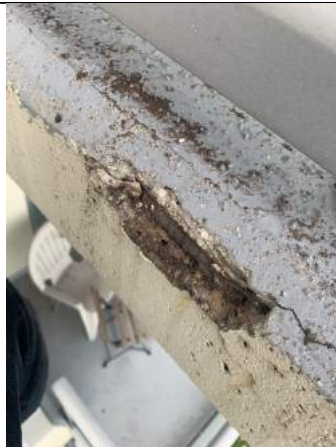
20

On many balconies the concrete is crumbling to the point where internal rebar is visible.

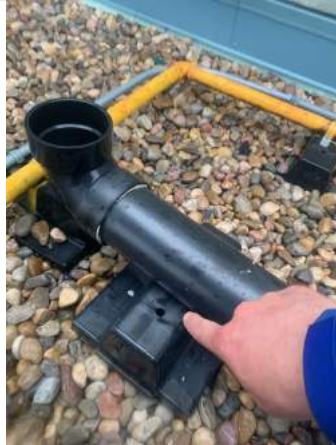
13

Vent pipe is not secured to the roof sleeper. A properly secured pipe is important because it prevents both the pipe and the sleeper from moving and becoming a fall risk.

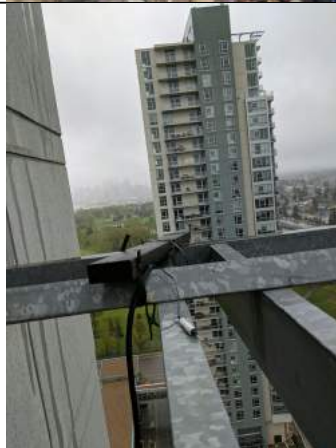
11, 12

Rotting dimensional lumber was observed supporting fixtures at several places on the roof. If this set up is not replaced, the fixtures (i.e. cameras, etc) will eventually fall off the roof. If wood is to be used for a support, it should be pressure treated or sealed and should be monitored on a regular basis.

2. Some electrical items on the roof are attached by sub-par materials. The electrical boxes need to be attached by exterior grade fasteners, to prevent the hazard of the boxes falling to grade.
3. On the south side of the roof, there is an exhaust pipe that needs to be secured to the supports. The supports being unsecured, could easily blow away, creating a hazard for the public. These need to be attached with exterior grade fasteners.

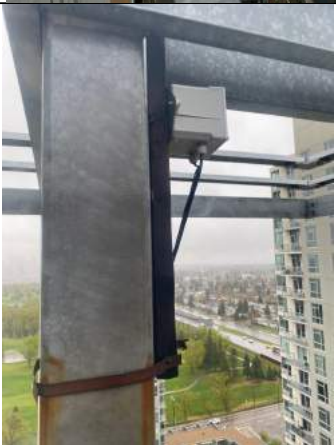
11,12

These electrical fixtures are supported by rusting metal straps and rotting lumber. These supports will eventually fail, and the system will drop off the building. Recommend replacing fixture support system.

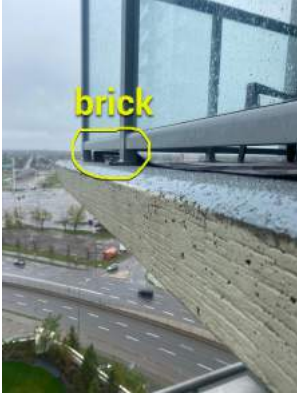
Item	Description	Recommendation
<p>Items unsecured or dangerously places on balconies.</p>

<p>Residents need to be reminded of the severity of the consequences, if something like this were to fall. This was found on the 16 floor, SE Corner of the Brava Building. The Brick is easily small enough for fit under the hand rail if kicked. Valiant moved the brick back from the edge, however it will likely reutrn. Valiant also noticed balconies on the NW corner of Encore that had empty boxes, garbages and other items that could easily blow off the building.</p>
<p>Items unsecured or dangerously places on balconies.</p>

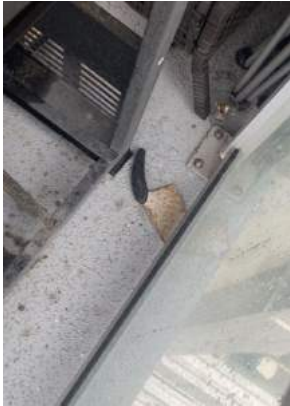
<p>Same issue here. A large knife just inches away from the edge of the balcony. Valiant moved the knife back from the edge, but again, it could be moved back.</p>
<p>Items unsecured or dangerously places on balconies.</p>

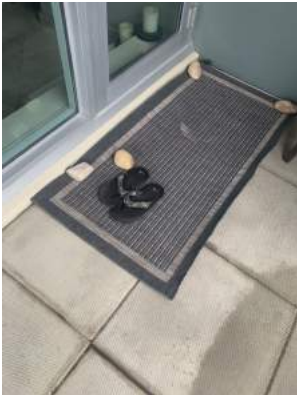
<p>Same issue again. Large rocks are a very bad idea to have on balconies. They are often inadvertently kicked, and certainly have the ability to cause serious injury or death if dropped from height.</p>

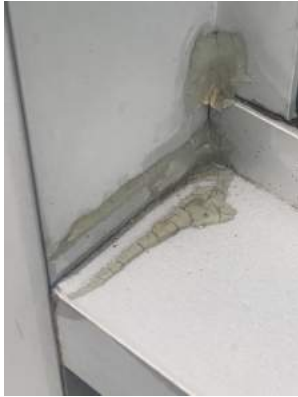
<p>This picture is typical for most windows on the Brava building. The caulking is completely failed in most cases. We recommend addressing this issue as soon as possible to prevent leakage and water damaged. See attached estimate for Valiant to address the caulking and sealing issues.</p>
<p>Caulking/Sealant</p>

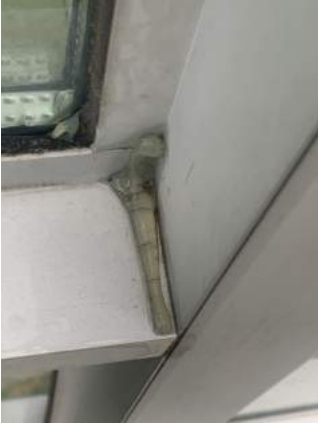
<p>Another example of the many windows where the frame is not sealed at all.</p>
<p>Damaging Walls w/BBQ's</p>

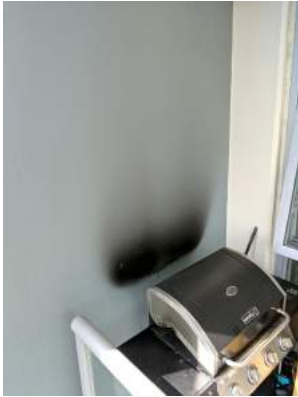
<p>Residents should be mindful of damaging walls with their BBQ's. This was found on the East Side, the set of balconies north of the building entrance.</p>
<p>Seemingly Random Hardware</p>

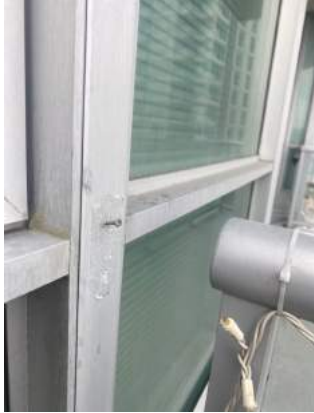
<p>There is random hardware throughout the building that doesnt appear to have any purpose. With it sticking out the way it is, it will likely corrode and fall down with time. This also allows water to enter the screw hole.</p>

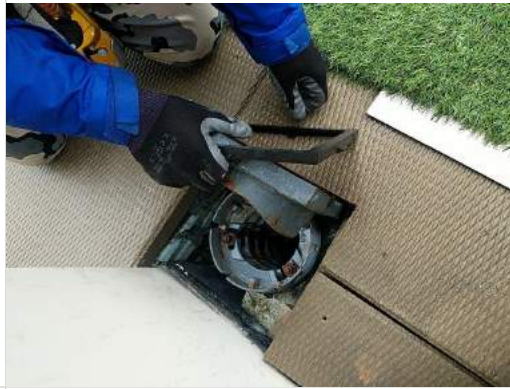
Drain cover not secured.

Found on the 22 floor penthouse. Drain cover not secured properly. Not a safety issue. However, if something was dropped into drain, could cause major plumbing issues.

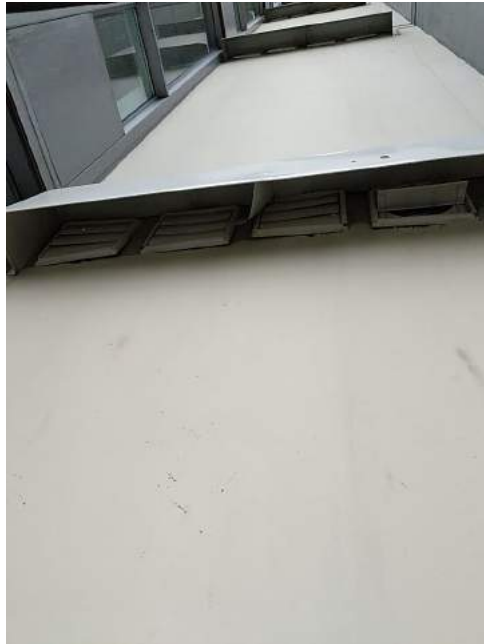
Vents cracked and deteriorated.

Vents dirty, cracked and in need of replacement. If left as is, birds can get into louvers and makes nests, which will block off the vent.

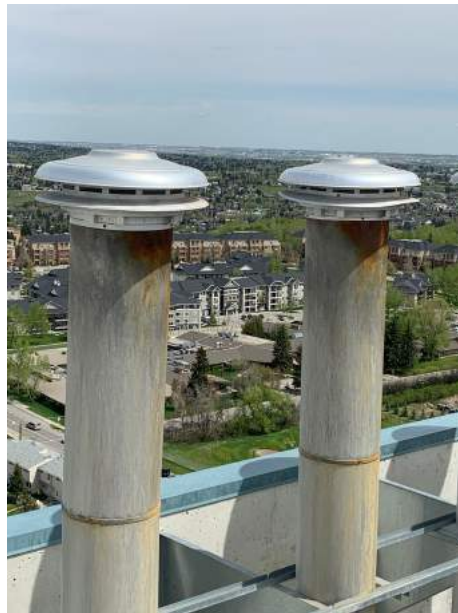
Rusting stacks

Rusting at exhaust vents was observed. Rust can loosen the screws that attach cap flashing. Unsecured cap flashings can be blown off the roof by the wind.
